Building Inspection Report

Property Address:
XXXX Eastlake Ave. E.
Seattle WA

Axiom Building Inspections

Date: 9/20/2010	Start Time: 09:00 AM	Report ID:
Property: XXXX Eastlake Ave. E. Seattle WA	Client: Commercial Building Owner	Real Estate Professional:

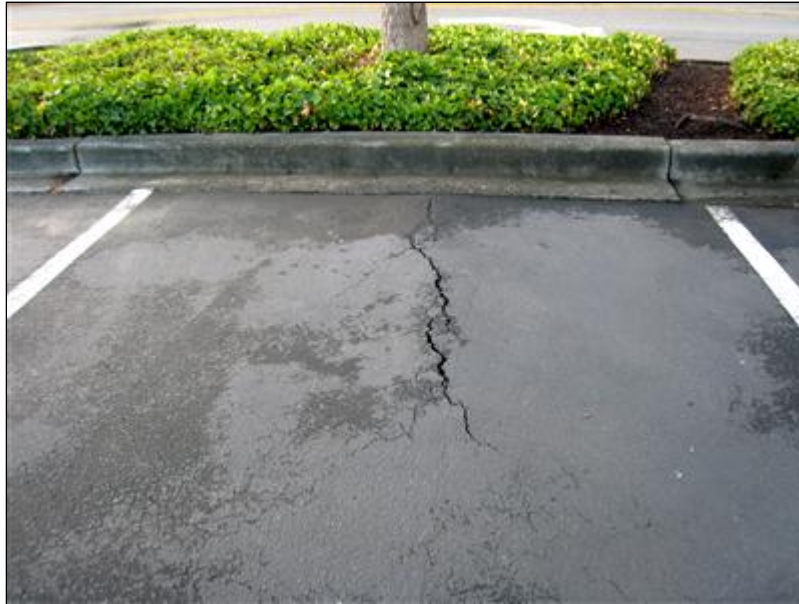
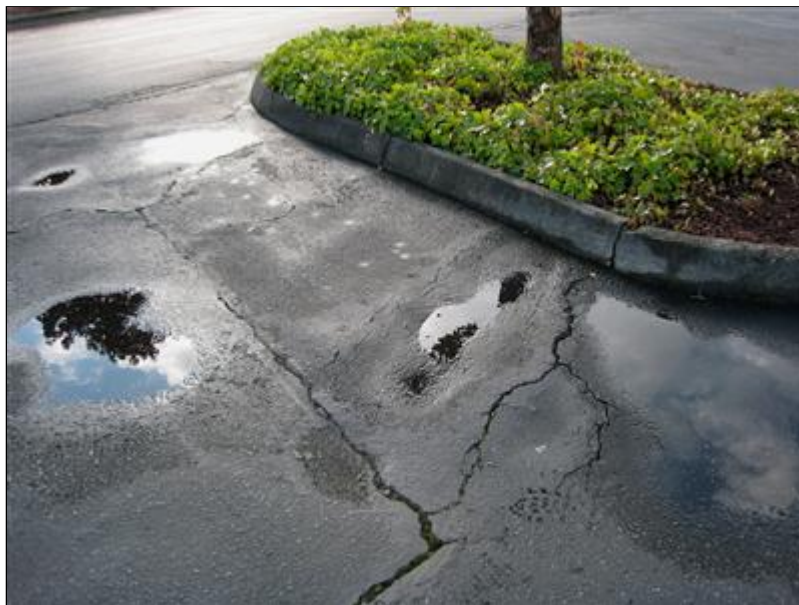
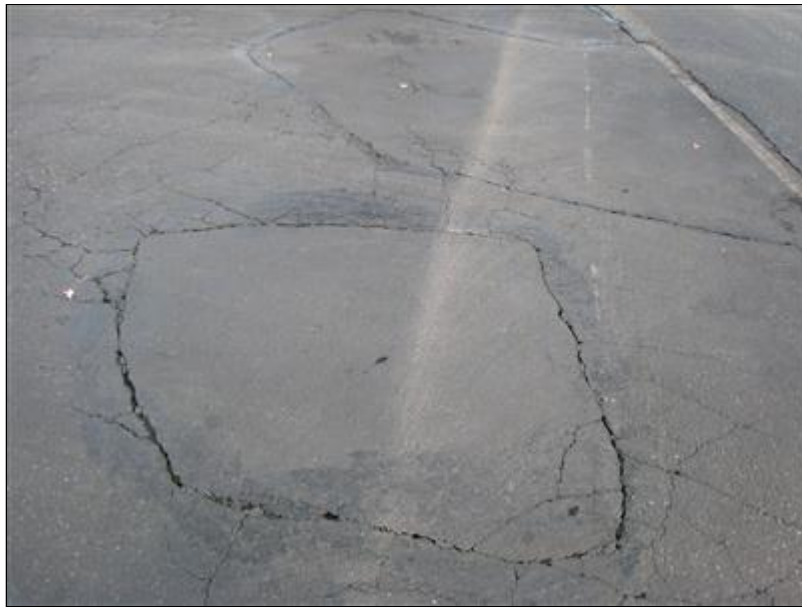
1.0 The asphalt paving in the parking area is cracked and buckled in several areas. Tree roots have caused the asphalt to buckle at the south end of the lot and at the north end of the west side. Cracks appear in the asphalt in the south and west

sides of the lot. Vegetation has not yet taken root in the cracks. There is minor water ponding, but generally the surface drainage is good. I recommend that a paving contractor resurface/repair the asphalt in the near future. Cracks result in an increased rate of deterioration of the asphalt and allow vegetation to take hold. The tree roots will continue to cause damage to the paving unless the trees are removed or replaced with a variety with less intrusive roots.

The asphalt paving in the parking area is cracked and buckled in several areas. Tree roots have caused the asphalt to buckle at the south end of the lot and at the north end of the west side. Cracks appear in the asphalt in the south and west sides of the lot. Vegetation has not yet taken root in the cracks. There is minor water ponding, but generally the surface drainage is good. I recommend that a paving contractor resurface/repair the asphalt in the near future. Cracks result in an increased rate of deterioration of the asphalt and allow vegetation to take hold. The tree roots will continue to cause damage to the paving unless the trees are removed or replaced with a variety with less intrusive roots.

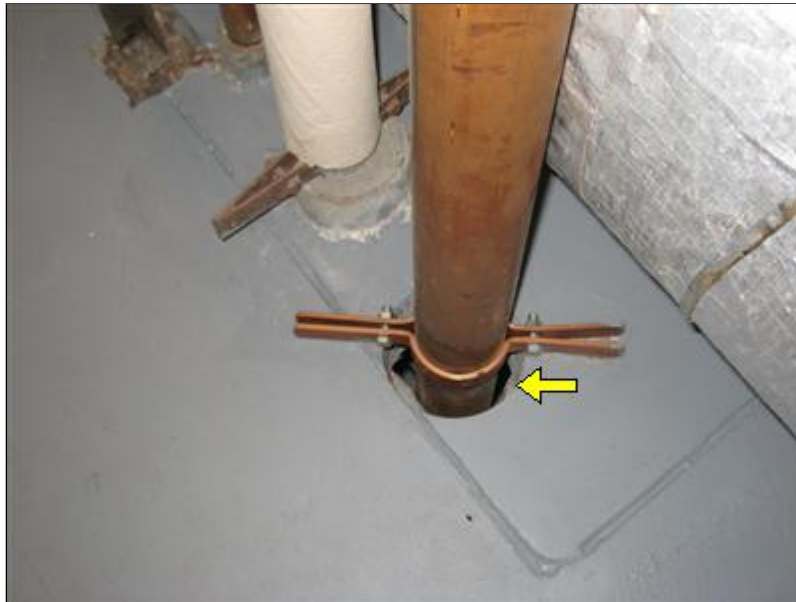
2.3 Picture 1

2.3 The annular space around a pipe in the floor of the 4th floor mechanical room is not sealed with fire-rated material.

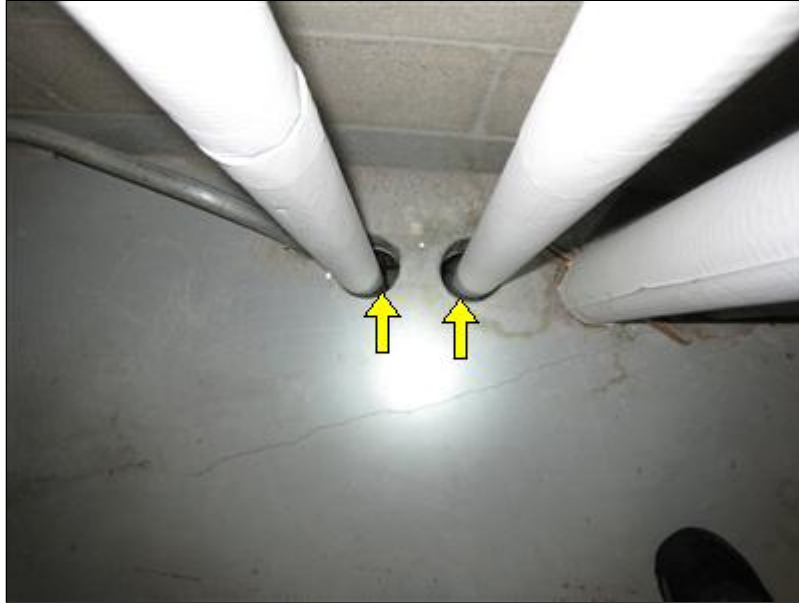
2.3 Picture 2

The annular spaces around two pipes in the floor of the 2nd floor mechanical room are not sealed with fire-rated material.

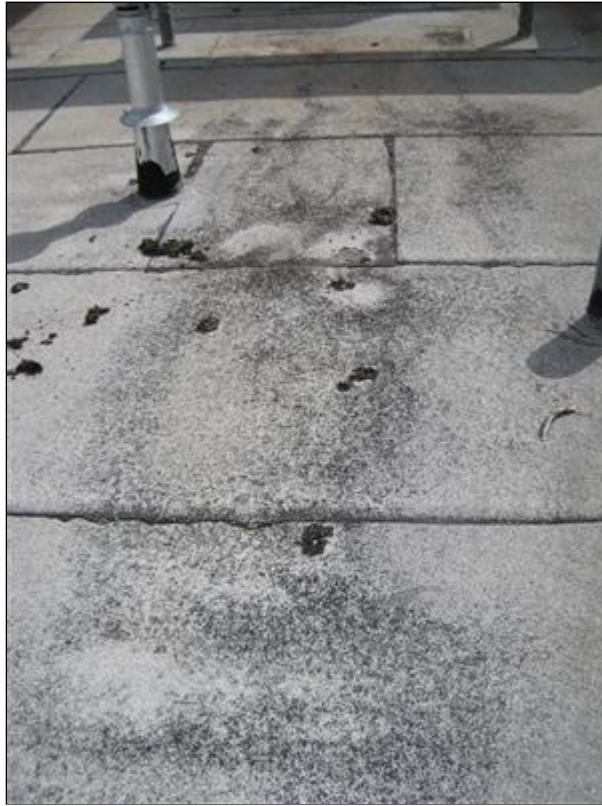
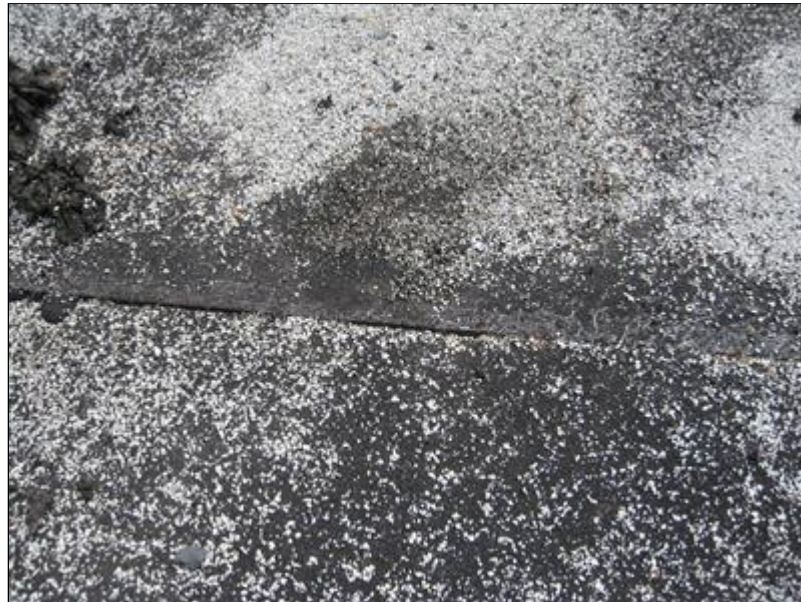
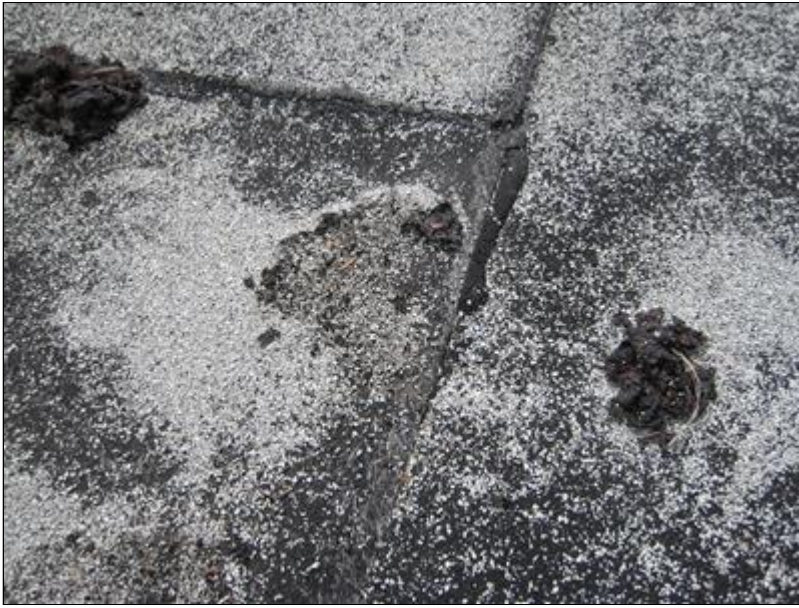
3.0 Excessive erosion of the granule coating on the roof covering has occurred in the area of the roof from the HVAC package unit to the east drainage scupper. Water flowing to the drainage scupper is the likely cause of the erosion. The bituminous base and fiberglass mat of the roof covering are exposed to harmful UV rays, which will shorten its lifespan. I recommend that the roof covering is evaluated by a roofing contractor who should provide a remedy.

Excessive erosion of the granule coating on the roof covering has occurred in the area of the roof from the HVAC package unit to the east drainage scupper. Water flowing to the drainage scupper is the likely cause of the erosion. The bituminous base and fiberglass mat of the roof covering are exposed to harmful UV rays, which will shorten its lifespan. I recommend that the roof covering is evaluated by a roofing contractor who should provide a remedy.

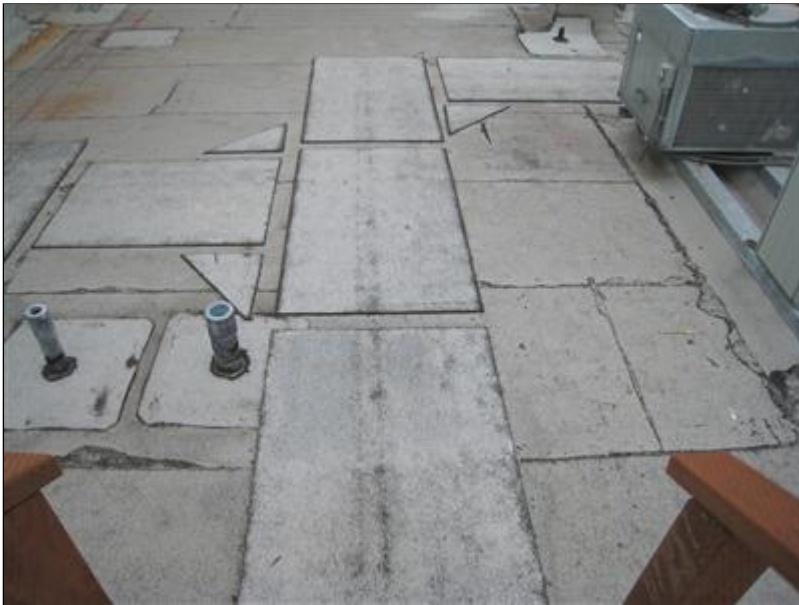
3.0 Picture 4

Walking pads are installed on the roof in pathways and near mechanical equipment to protect the roof covering from foot traffic.

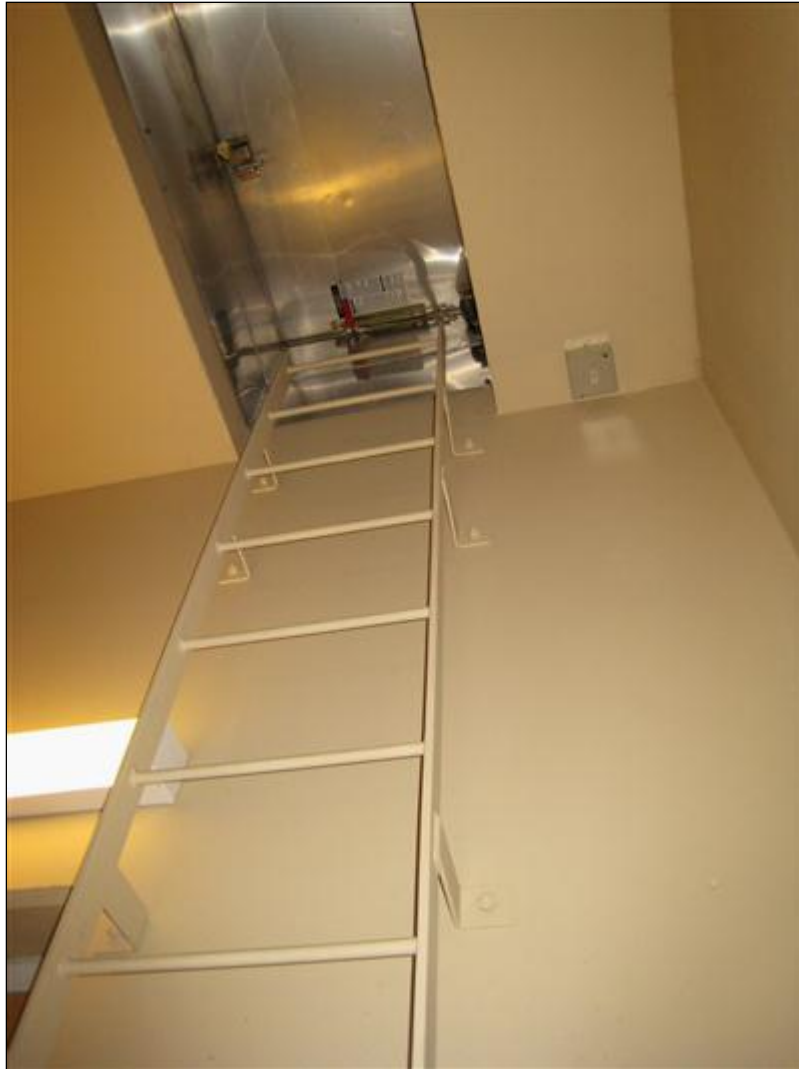
3.6 Picture 1

3.6 Roof access is achieved through a roof hatch and a permanently installed metal ladder. The ladder should have a fall cage for safety reasons. More information on OSHA requirements for permanently installed ladders is available at:

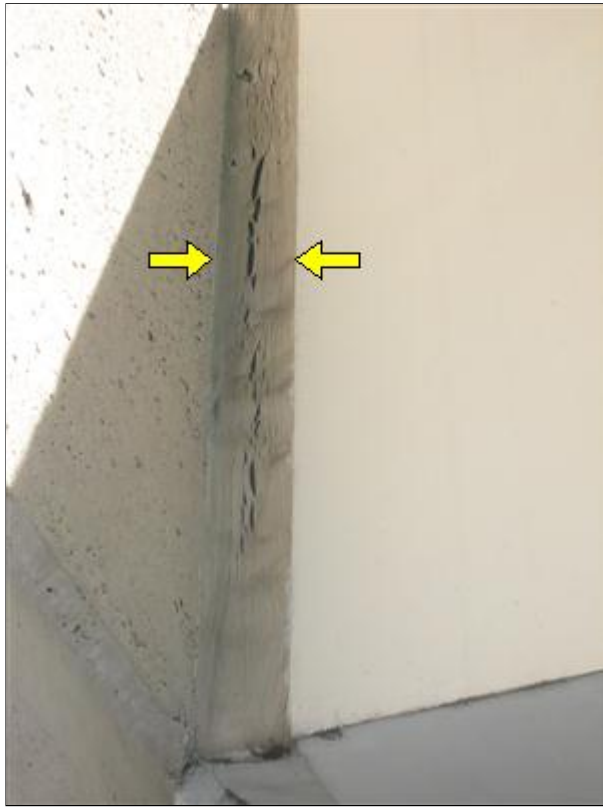
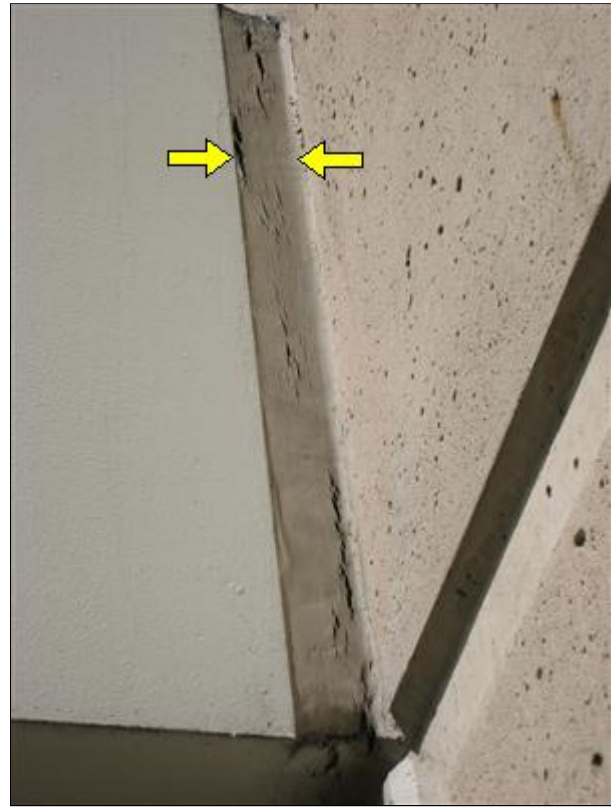
4.0 A wide caulk joint (about 2") at the intersection of the portico and the main building is cracked. The cracked caulk joint appears on both the east and west sides of the portico. The joint is too wide for an effective application of flexible caulk. I recommend that a contractor provide a method that fills and seals the gap.

A wide caulk joint (about 2") at the intersection of the portico and the main building is cracked. The cracked caulk joint appears on both the east and west sides of the portico. The joint is too wide for an effective application of flexible caulk. I recommend that a contractor provide a method that fills and seals the gap.

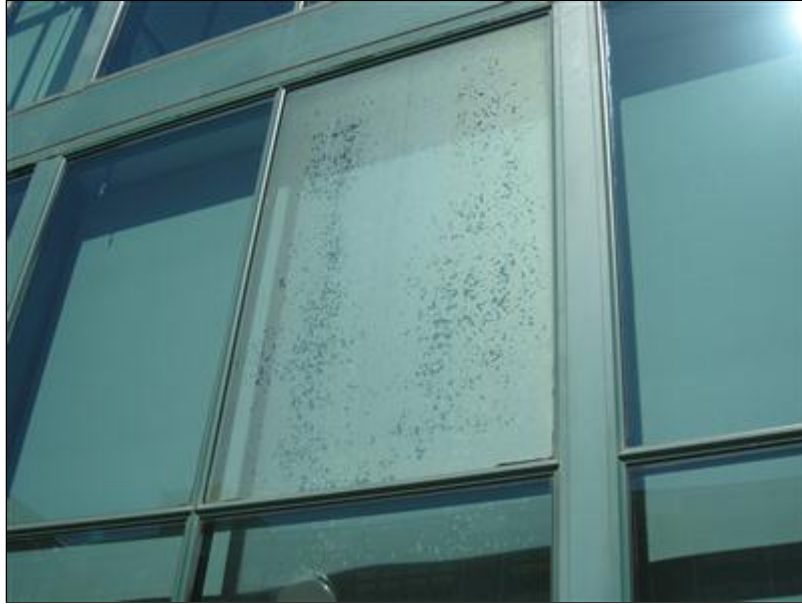
4.1 Picture 1

4.1 Two panes of glass with defective reflective coatings were noted. The panes are at street level and are located on the north and south ends of the east side.

Two panes of glass with defective reflective coatings were noted. The panes are at street level and are located on the north and south ends of the east side.

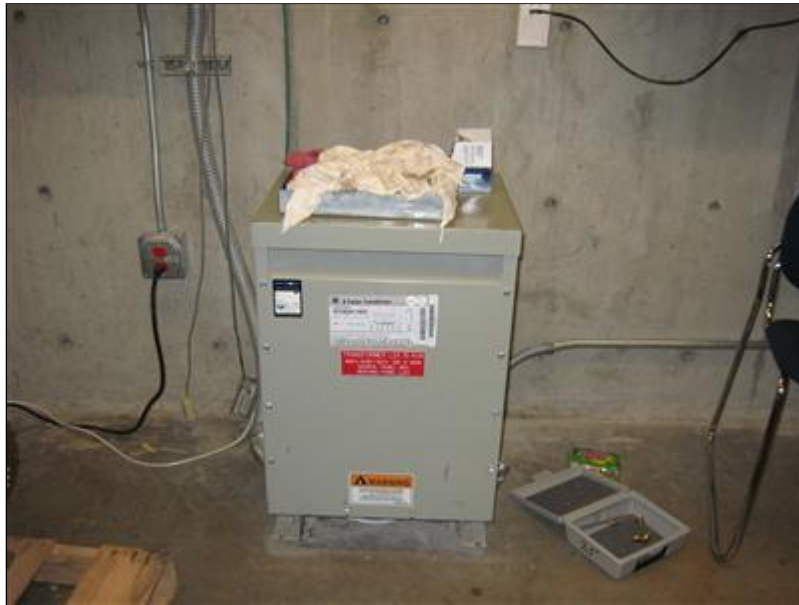
5.1 Picture 1

5.1 Rags were noted on the top of a transformer in Mechanical Room 222. The facilities manager present at the inspection, cleared the items and stated he will inform his staff to keep electrical equipment clear.

Rags were noted on the top of a transformer in Mechanical Room 222. The facilities manager present at the inspection, cleared the items and stated he will inform his staff to keep electrical equipment clear.

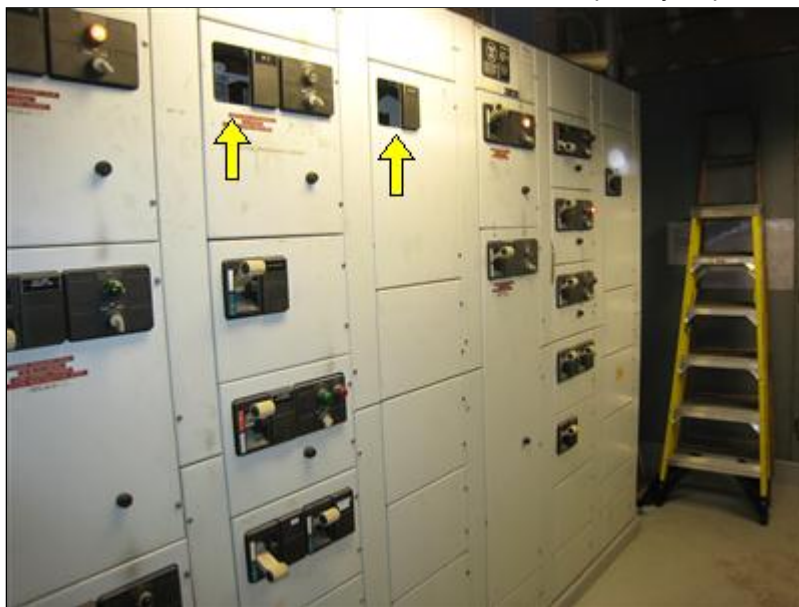
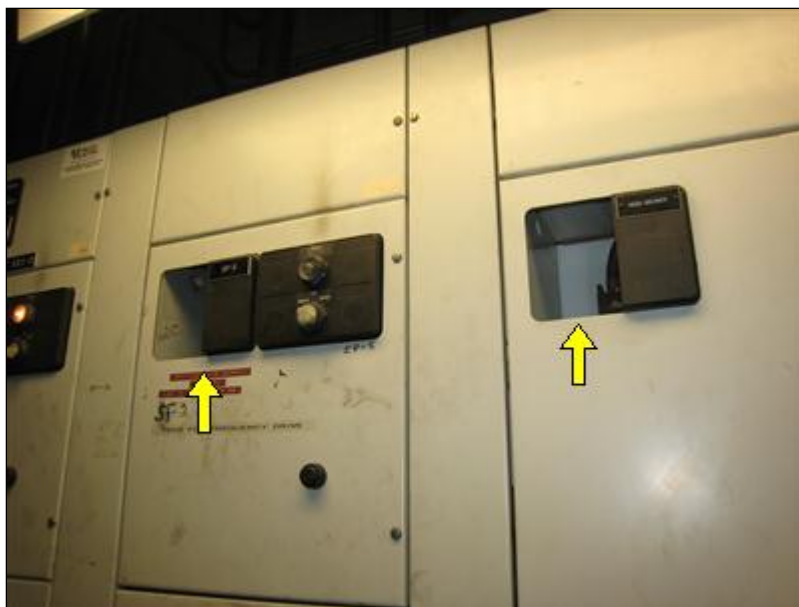
The motor control center in the east mechanical room has two covers missing on the main breakers. The openings expose live wiring and would fail to contain an electrical fire. I recommend repair by a qualified electrician.

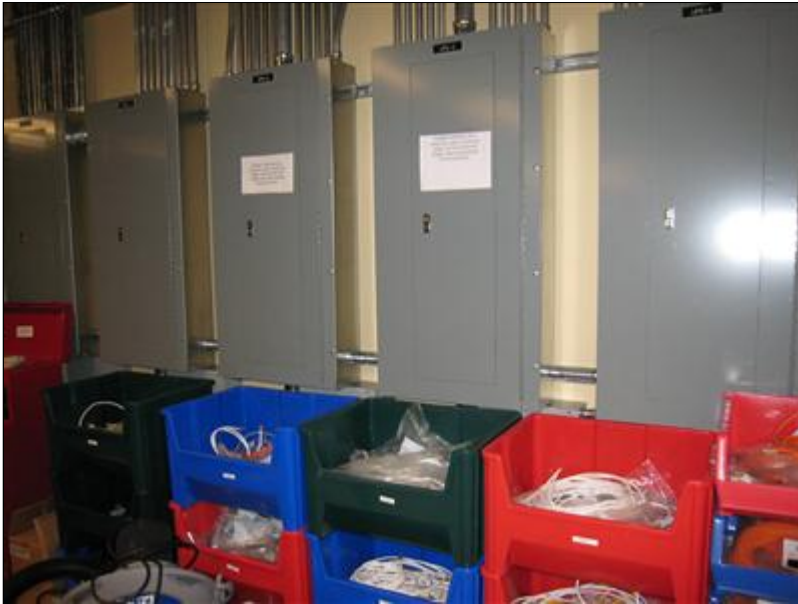
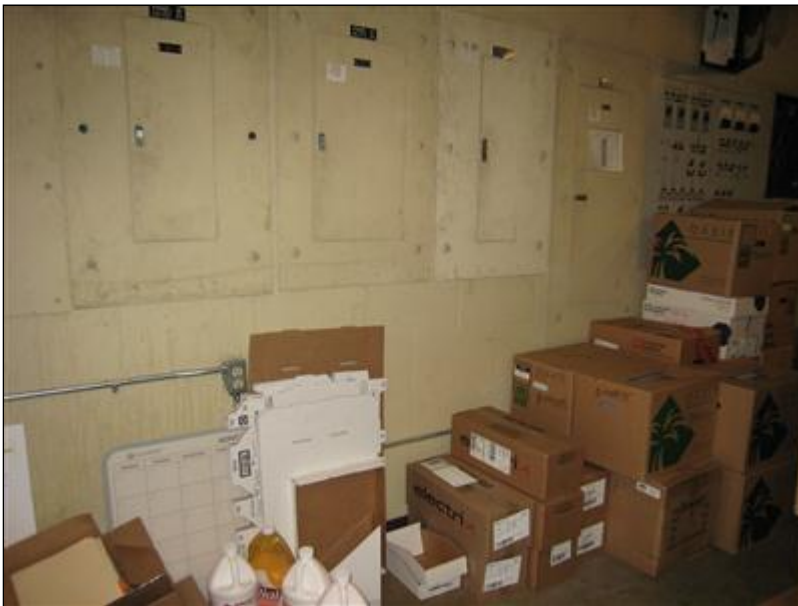
5.2 Stored items have been placed on the floor in front of electric service panels in the main server room and in Mechanical Room 222. In Section 110.26 of the National Electrical Code, it requires that a clear space 30 inches wide, 36 inches deep, and 78 inches high be maintained in front of electrical equipment. The purpose is to provide safe access for service personnel, for quick access in an emergency situation, and for fire safety reasons. I recommend that adequate access to the electric service equipment be achieved for safety reasons.

Stored items have been placed on the floor in front of electric service panels in the main server room and in Mechanical Room 222. In Section 110.26 of the National Electrical Code, it requires that a clear space 30 inches wide, 36 inches deep, and 78 inches high be maintained in front of electrical equipment. The purpose is to provide safe access for service personnel, for quick access in an emergency situation, and for fire safety reasons. I recommend that adequate access to the electric service equipment be achieved for safety reasons.

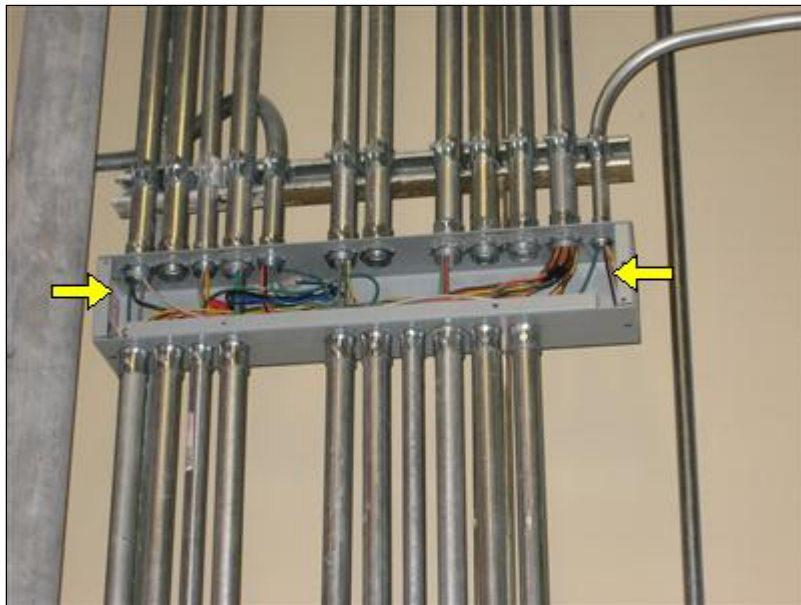
5.3 Picture 1

5.3 The cover is not installed on the wiring gutter in the first floor electrical room, exposing wire splices. I recommend that an electrician replace the cover.

The cover is not installed on the wiring gutter in the first floor electrical room, exposing wire splices. I recommend that an electrician replace the cover.

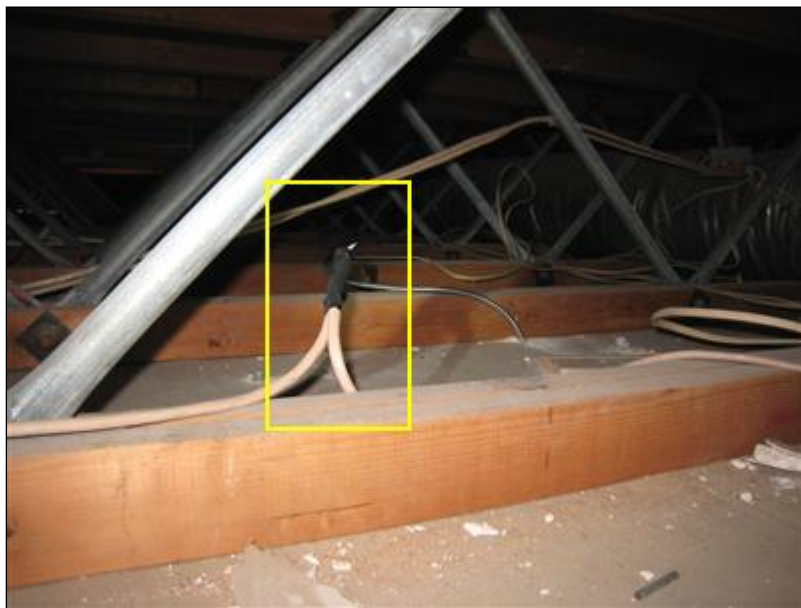
5.3 Picture 2

Spliced wires are not enclosed in an electrical junction box above the ceiling in Office 110. I recommend repair by an electrician.

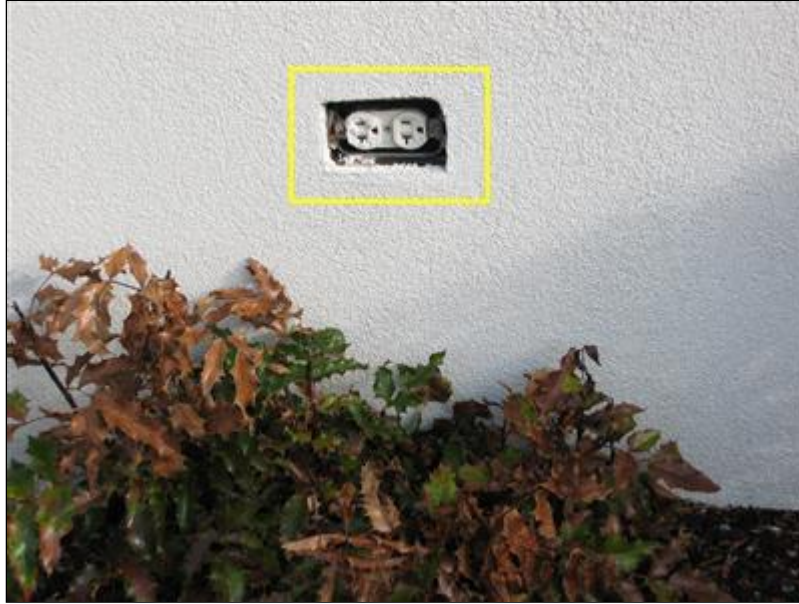
5.6 Picture 1

5.6 The exterior receptacles on the south and north walls are not rated for outdoor exposure and are not GFCI protected. No power was present at the receptacles at the time of the inspection. A ground fault circuit interrupter (GFCI) is a modern electrical device, either receptacle or circuit breaker, which is designed to protect people from electric shock. In the event of a fault in an appliance, someone touching the appliance could become the path to ground for the current. The GFCI shuts off power in the circuit and protects someone from receiving a potentially fatal shock. For the protection of occupants, GFCIs are required in wet or damp environments in new or remodeled buildings, and are recommended in all buildings. I recommend that a qualified electrician install GFCI protection at the receptacles at the required or

recommended locations in order to conform with modern safety standards and that the receptacles are rated for outdoor installations.

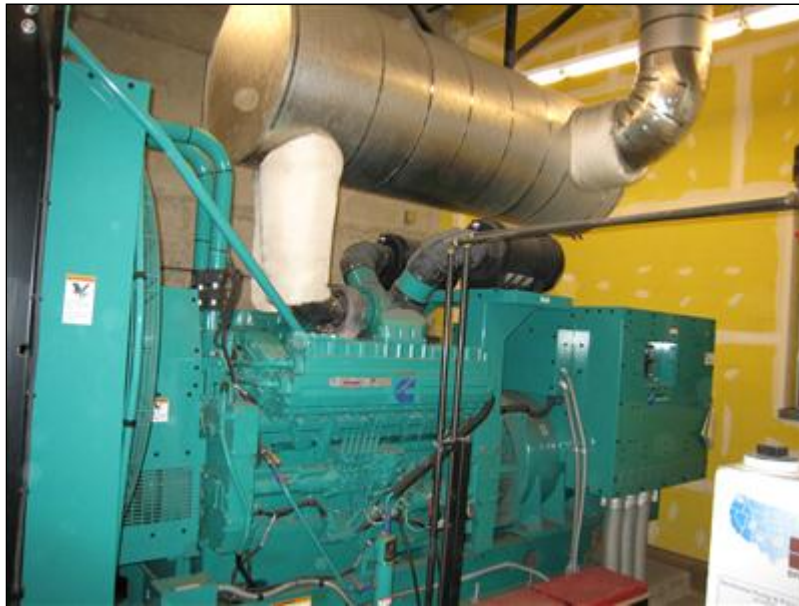
5.9 Picture 1

5.9 The instruments on the standby emergency generator indicated that it has had 94 starts and has run 34.0 hours. The on-site log book indicated that the generator is tested monthly. The generator room was tidy and provided adequate access for servicing.

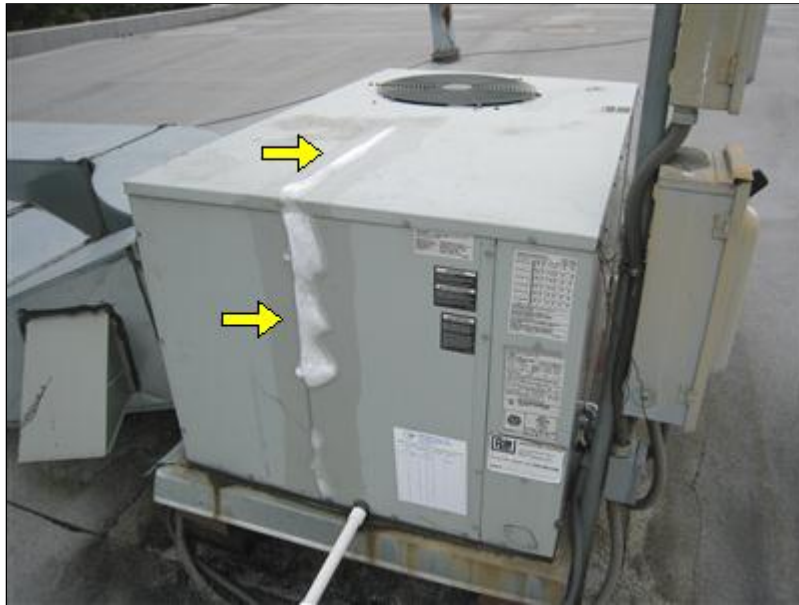
6.0 Picture 1

6.0 The roof-top Trane air conditioner package unit at the east end of the building was found running at the time of the inspection. The unit had a build up of ice on the coils and cabinet and no air was moving through. I recommend repair by a HVAC technician.

The roof-top Trane air conditioner package unit at the east end of the building was found running at the time of the inspection. The unit had a build up of ice on the coils and cabinet and no air was moving through. I recommend repair by a HVAC technician.

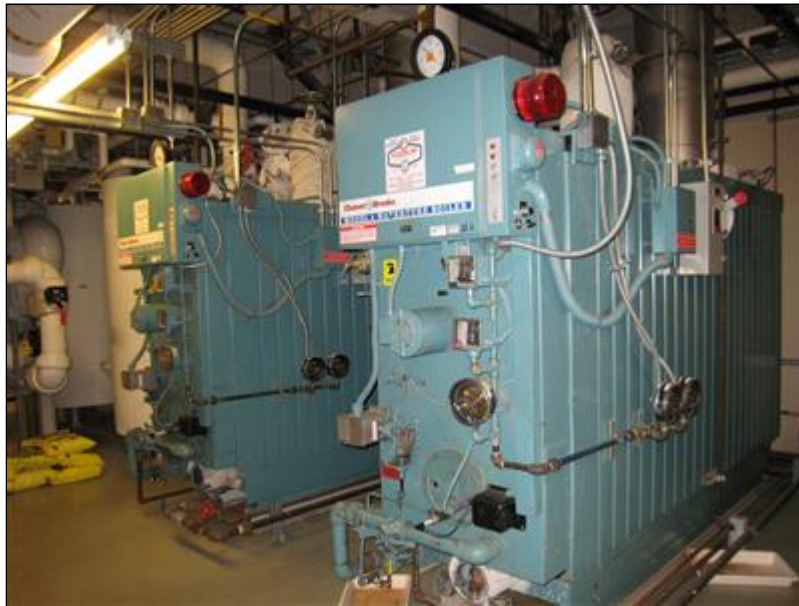
6.4 Picture 1

6.4 The pressure gauges on the boilers indicated that Boiler #1 was operating at 120 p.s.i. and Boilers #2 and #3 were operating at 110 p.s.i. The maximum working pressure stated on the data plate is 150 p.s.i.

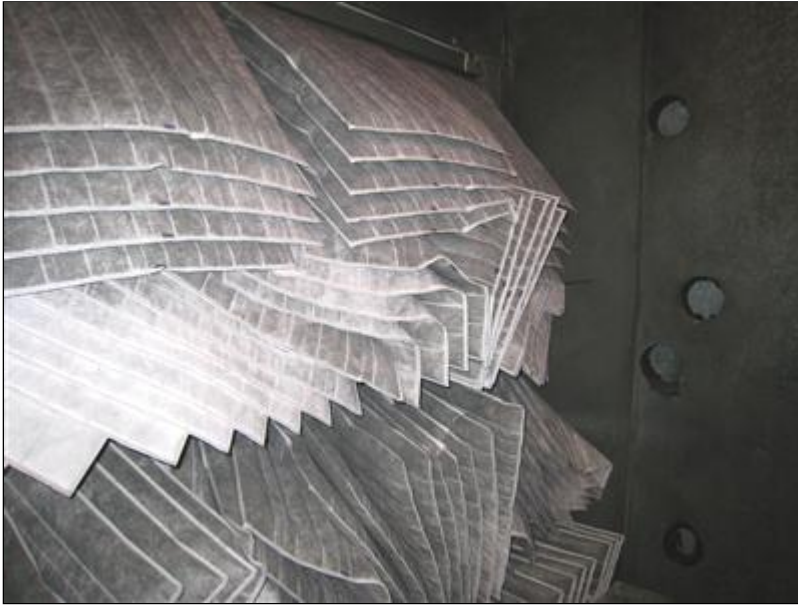
6.9 Picture 1

6.9 According to the building engineers logs, the pre-filters were changed two months ago and the bag filters in the air handlers were last changed eight months ago. The logs indicated that pre-filters are scheduled for replacement seasonally and the bag filters are scheduled for replacement annually.

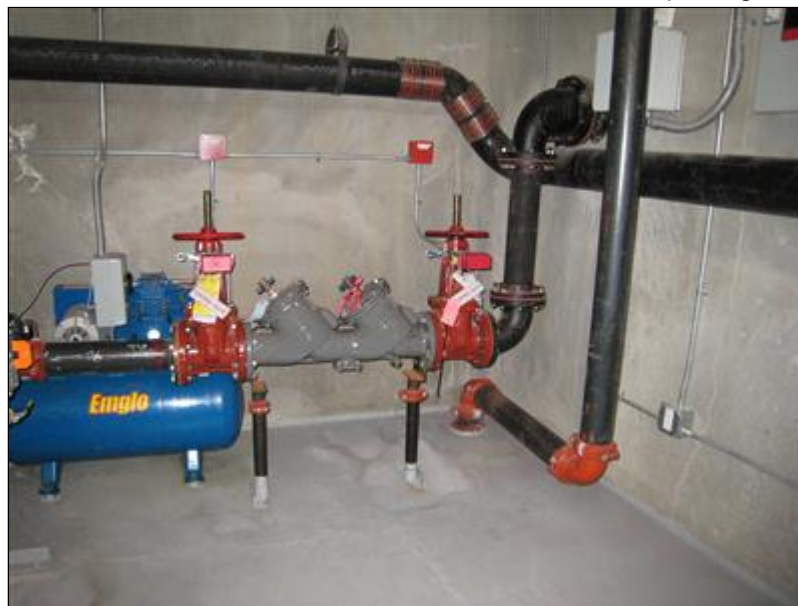
7.4 Picture 1

7.4 The main water shut-off valves are located in the water distribution room in the parking structure.

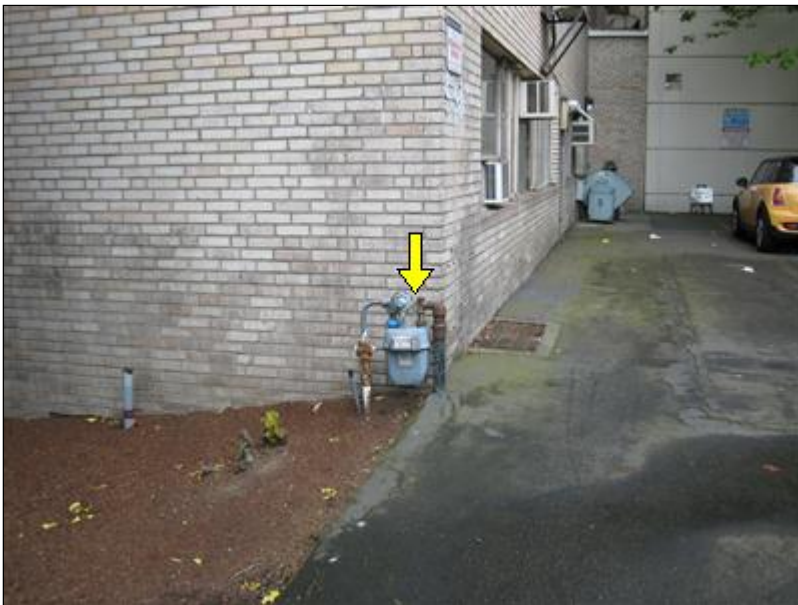
7.5 Picture 1

7.5 The gas meter at the east side of the building is installed adjacent to a driveway and is not protected from possible vehicle impact. I recommend that a bollard is installed to protect the meter and gas pipes for safety reasons.

The gas meter at the east side of the building is installed adjacent to a driveway and is not protected from possible vehicle impact. I recommend that a bollard is installed to protect the meter and gas pipes for safety reasons.

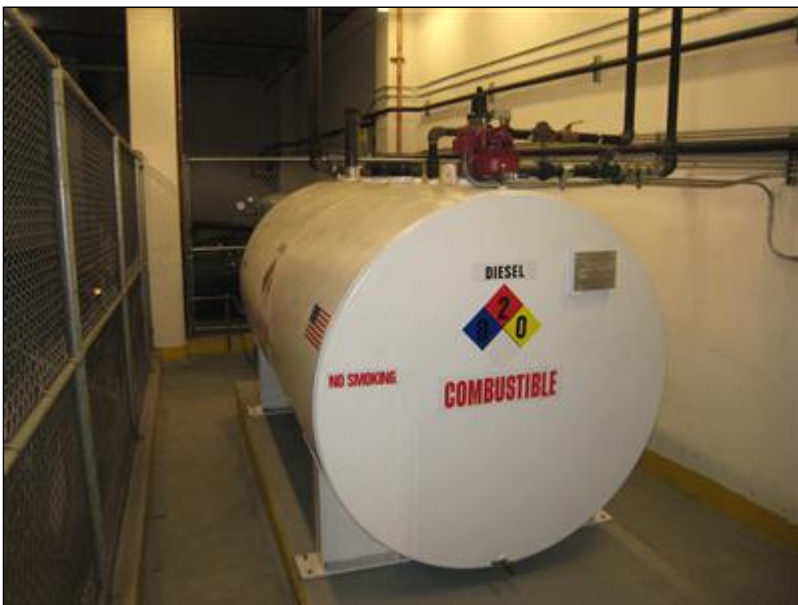
7.5 Picture 2

A 1,200 gallon fuel tank is installed in the same room as the standby generator. The steel tank is double-walled and UL listed as a protected secondary containment tank.

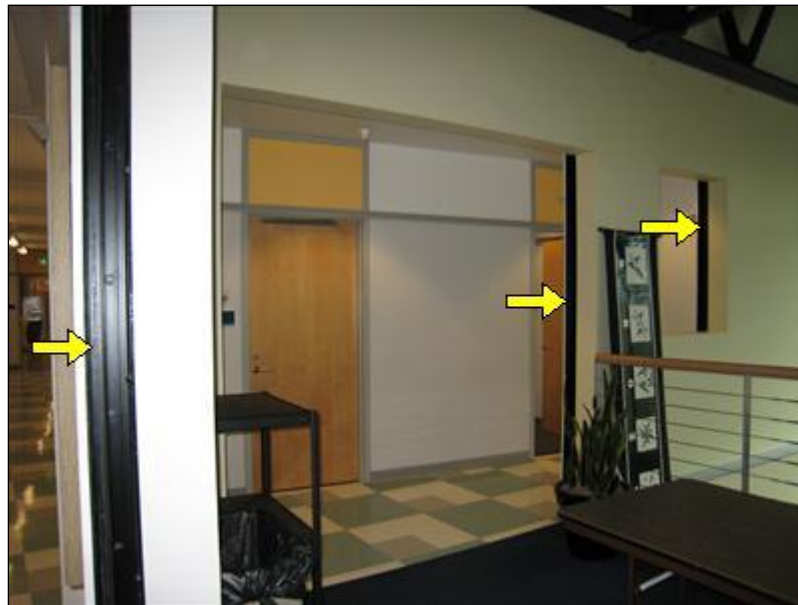
8.3 Picture 1

8.3 In response to fire safety requirements, automated sliding doors are installed in the walls above the lobby and atrium. If the fire alarm is triggered, the doors slide closed and separates the open atrium spaces from the hallways and offices. The doors are fire rated for 1 1/2 hours.

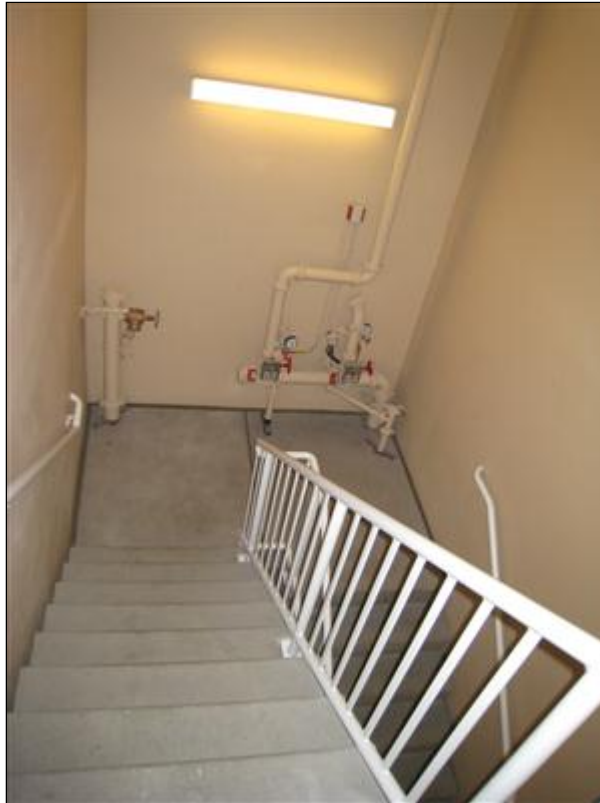
8.6 Picture 1

8.6 The building has three enclosed stairwells. The were stairwells were clear of stored items and well lit. The doors to the stairwells at each floor level were unlocked. Illuminated exit signs were installed at all of the stairwell doors.

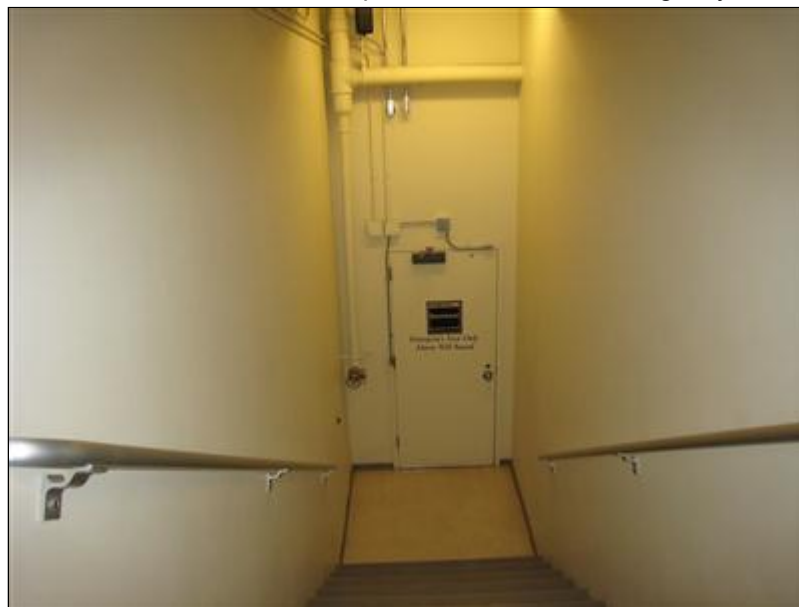
8.7 Picture 1

8.7 The exit door at the lowest level of Stairway 2 is inaccurately labeled as an emergency exit. The door has a lock with a 15-second delay. The door half a floor higher has an illuminated exit sign and is the correct means of emergency egress to street level. In an emergency situation, occupants would instinctively follow the stairs to the lowest level. I recommend that a gate or other device is installed that will direct occupants to the correct emergency exit.

The exit door at the lowest level of Stairway 2 is inaccurately labeled as an emergency exit. The door has a lock with a 15-second delay. The door half a floor higher has an illuminated exit sign and is the correct means of emergency egress to street level. In an emergency situation, occupants would instinctively follow the stairs to the lowest level. I recommend that a gate or other device is installed that will direct occupants to the correct emergency exit.

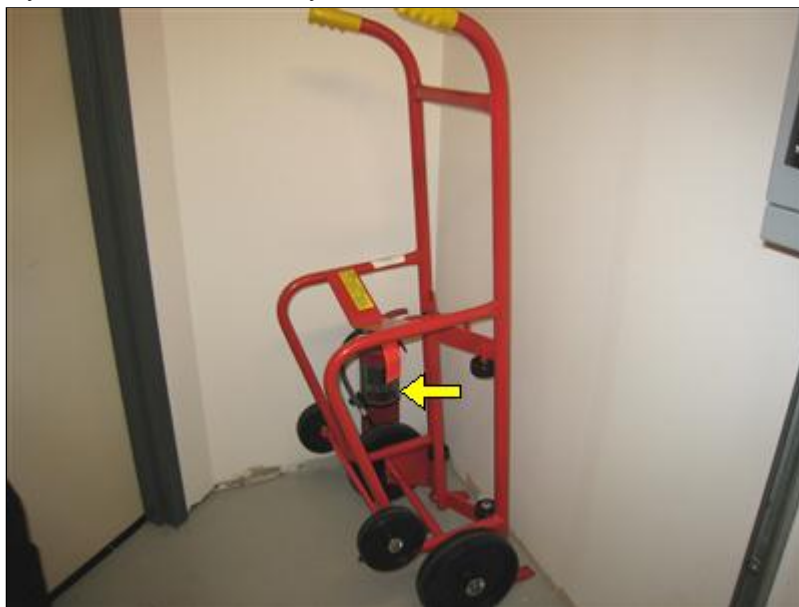
8.7 Picture 2

The fire extinguisher in the elevator control room was on the floor and not mounted on the wall. A wall-mounted extinguisher is easier to see and reach in an emergency situation and is less likely to be removed.

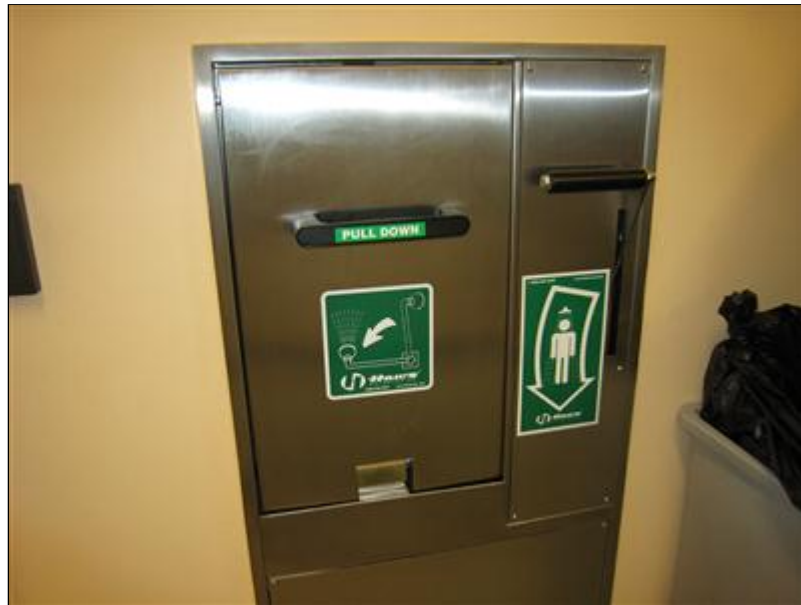
8.8 Picture 1

8.8 There are emergency shower and eye wash stations located in the labs and in the hallways in the lab areas. The station in the hallway on the north side of the third floor is not well signed. An additional sign should be posted on the wall above the station controls. A cart was present in front of the station at the time of the inspection. The station did not have an inspection tag. The other stations did have signs and inspection tags. The tags were dated 2007, 2008, and 2009. One station had striped caution tape applied to the floor. The tape helps identify the location of the station and deters people from storing items in the area. It would be a good idea to install caution tape at all of the stations.
